TRE10 Troughton & Simms Reflecting Telescope: Restoration

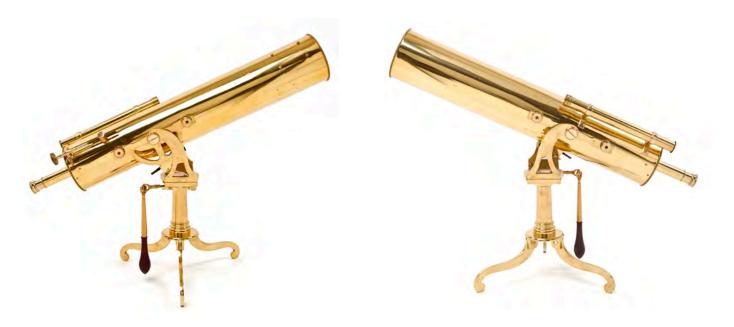
As Received

1) As received the condition of the telescope was rough. The telescope was badly dented and heavily corroded. It also came with two non-original slow-motion adjuster rods, but otherwise was sound and complete.

1) Restoration of total telescope was undertaken, but leaving the original refitted later glass mirror (c. 1860s?) as received; this included a period slow motion adjuster. Because of the stacked arrangement of the adjusters (one above the other), a second adjuster rod hangs awkwardly on top of the other. Therefore, functionally the one adjuster can be readily and easily used for either the altitude or azimuth positional adjustment.

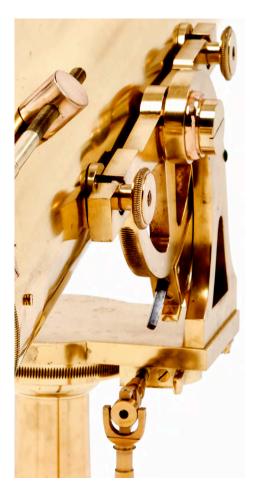
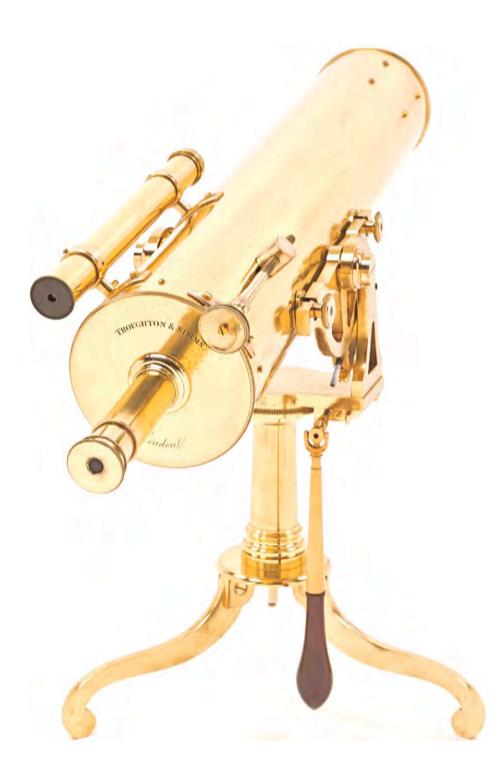
(sideview)

Stacked slow-motion adjusters make the use of two adjuster rods awkward with the top rod lying near direct on the lower adjuster; perhaps using a single adjuster was the original configuration, or alternatively a small knurled brass extension rod could have been used similar to TRE8.
