TRE7 75-mm Watson Reflecting Telescope: Repair and Restoration

TRE7 75-mm Watson Reflecting Telescope, c. 1790

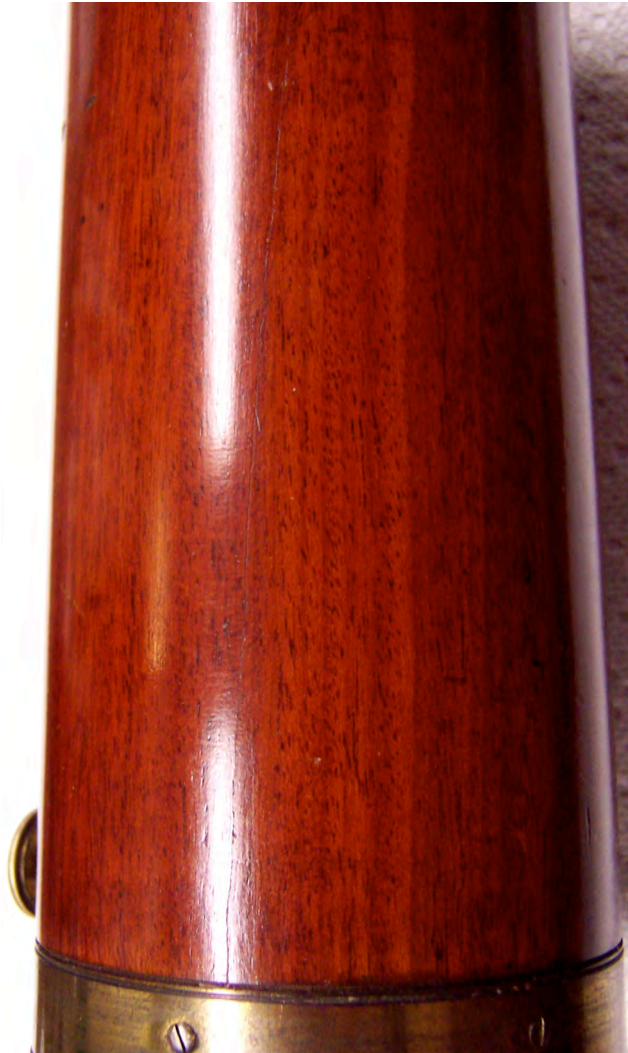
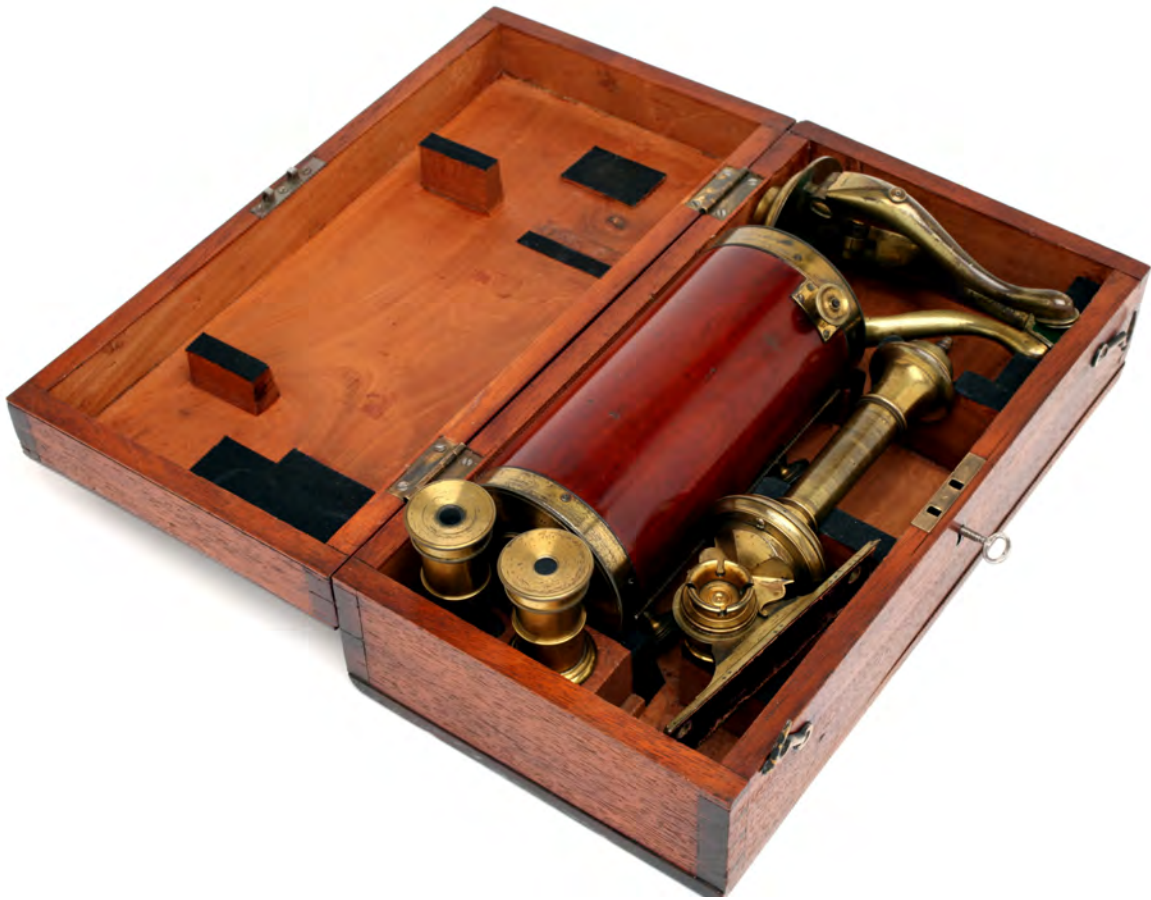
The solid mahogany tube had an 1/8th-inch wide shrinkage crack from one end to the other along the top (~ 7 inches) of the optical tube.

The "crack" was moved to the bottom of the tube where the mounting bracket, which ran the length of the tube would cover the new crack; easy to say, more difficult to explain. Essentially, the mahogany tube was split into two halves along the bottom of the tube. Then the old crack was closed on the top of the tube by rotating the two halves of the mahogany tube together. Once in place the tube was glued and clamped. The mahogany tube was then refinished and telescope was reassembled. The resulting hairline crack is barely visible - can just see it at the bottom of the photo (see blue arrow). Difficult to see the crack unless great care is taken to follow it along the tube as shown between the arrows below. The new crack on the bottom (out of view) is not visible unless the telescope is disassembled.
