FRA28 108-mm Merz et al Refractor Restoration

FRA28 Restoration

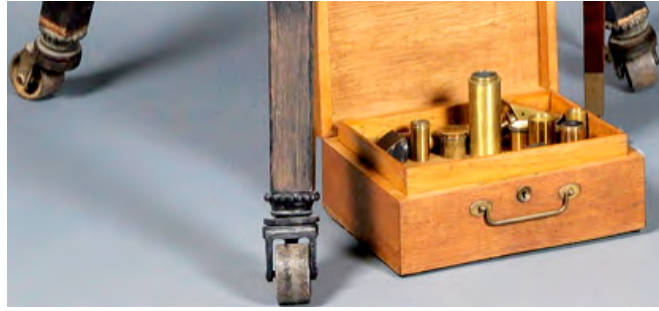
Before: Optical accessories came loose, but in a nice oak case.
Casters & decorative brass heavily corroded.

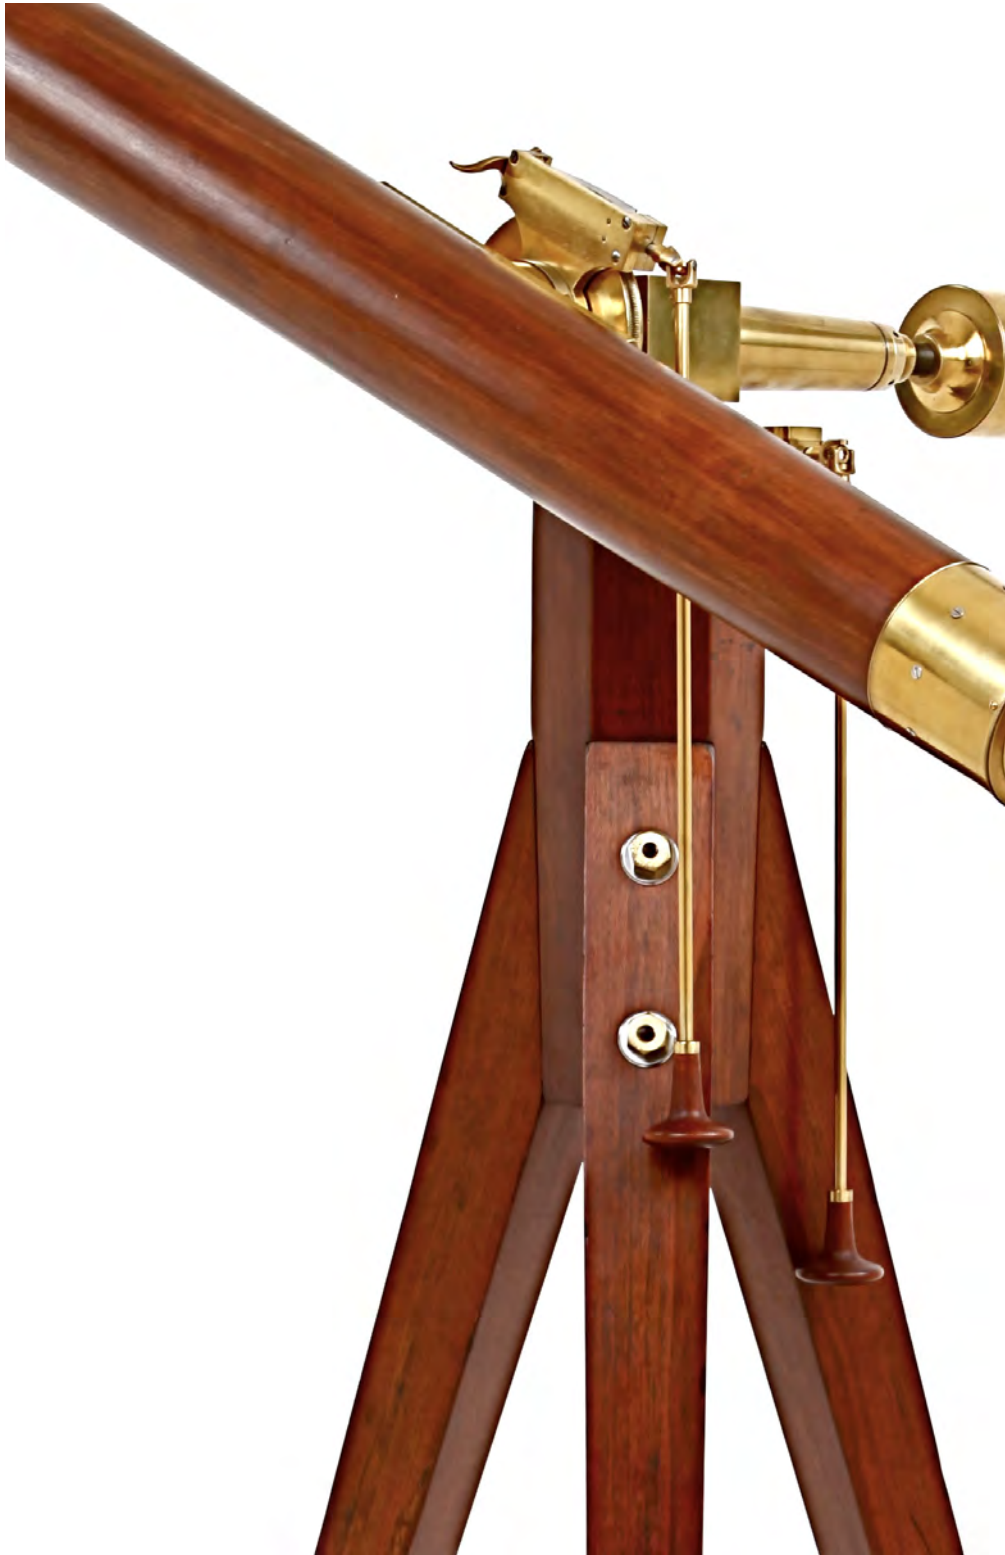
FRA28
Beautiful walnut tube and mahogany tripod
beneath the black antique paint!
