TRE17 150-mm Secretan Reflector: Restoration

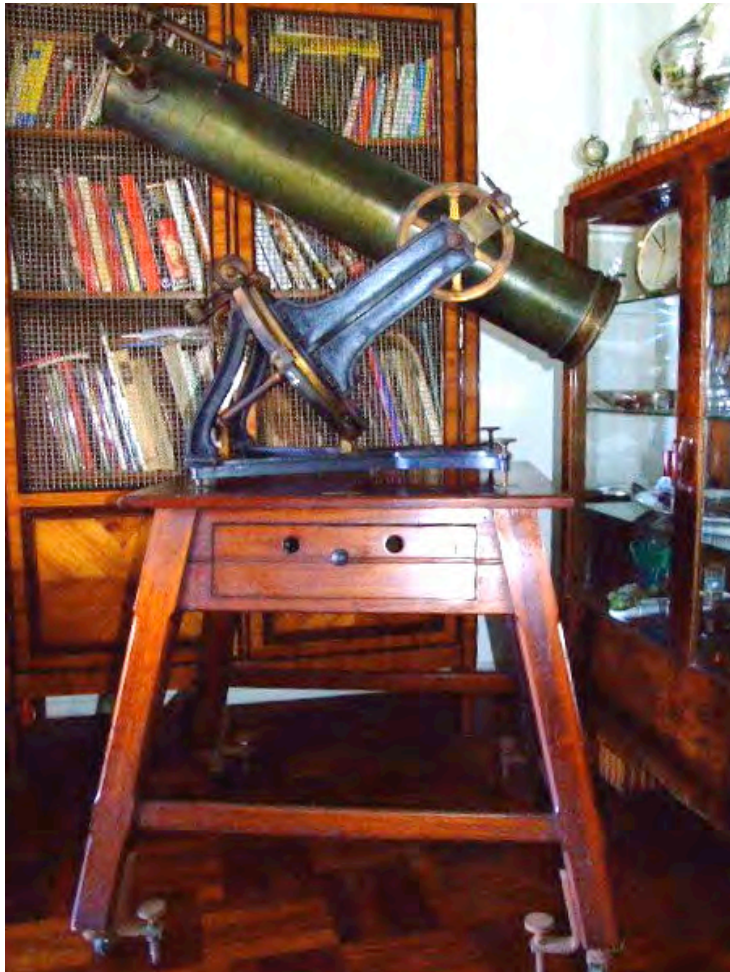
1. Came from Montevideo, Uruguay with all cast iron parts badly rusted and all brass heavily corroded.
2. Eyepiece for finder was missing.
3. The lever for engaging the right ascension adjuster was missing.

In Uruguay before shipment

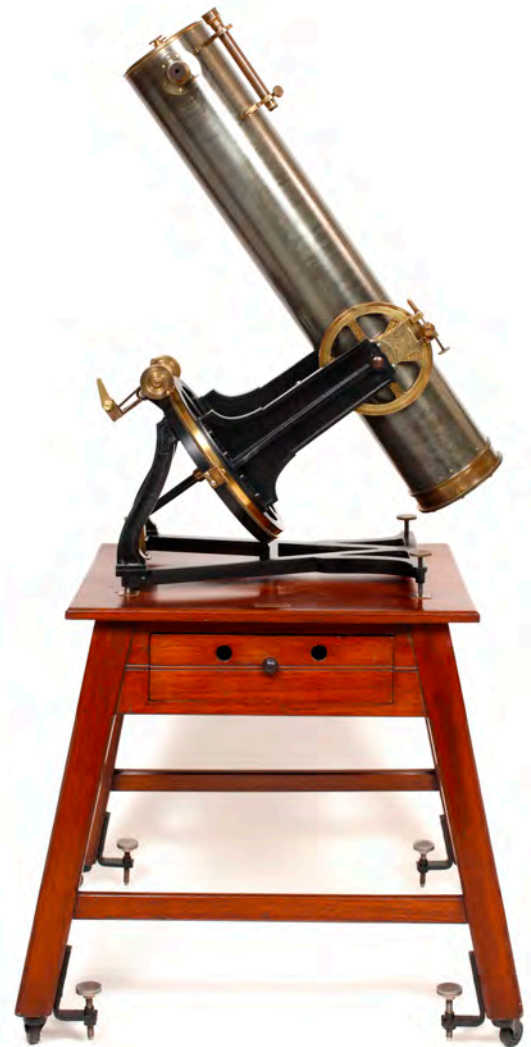
After restoration

1. Carefully cleaned rusted iron parts and repainted with satin black enamel
Brass parts were cleaned by not down to bare brass - all tooling marks were left
2. I was fortunate to find an eyepiece replacement that works just fine.
3. Designed a new engaging lever and keeper nut (see photos) - used retainer flanges on inside of the end cap as a design guide for the lever.

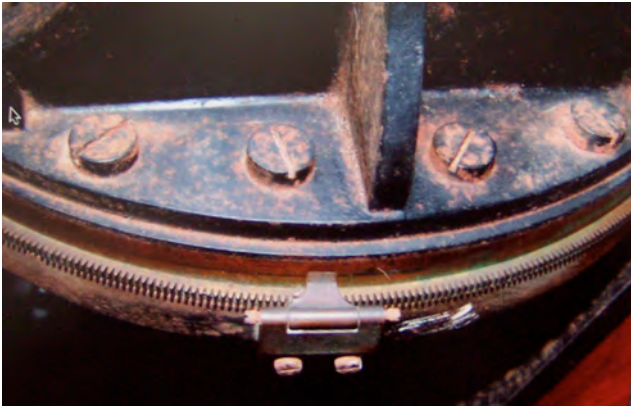
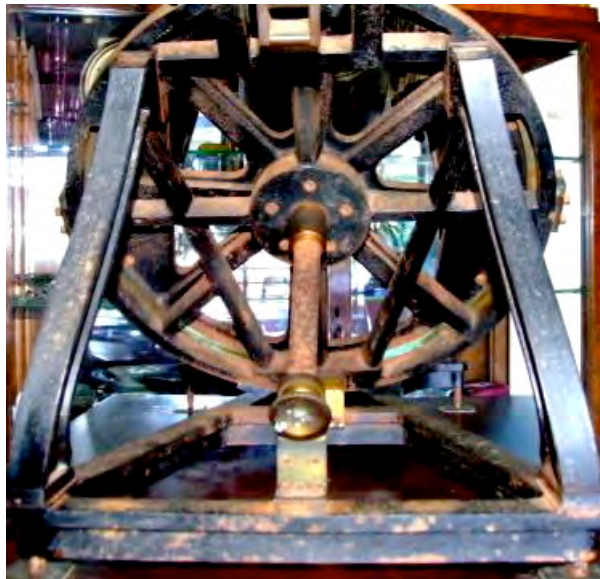
Before

After

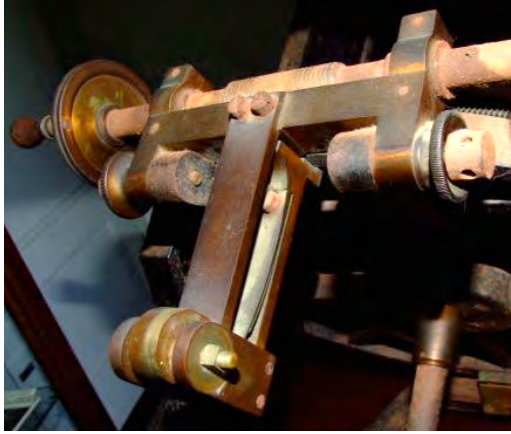
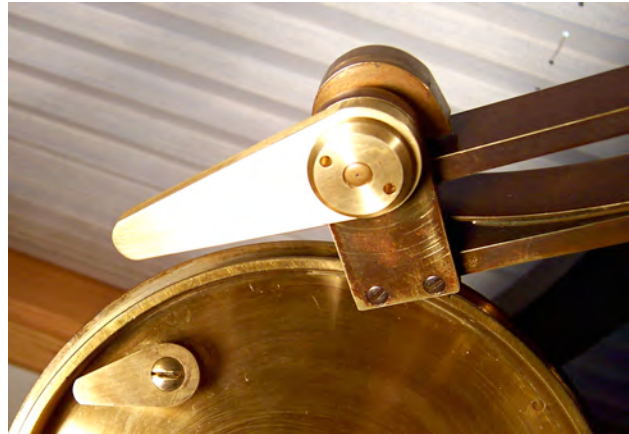
Replaced missing lever and keeper nut (twist tab on main tube lid was used for designing shape of lever)

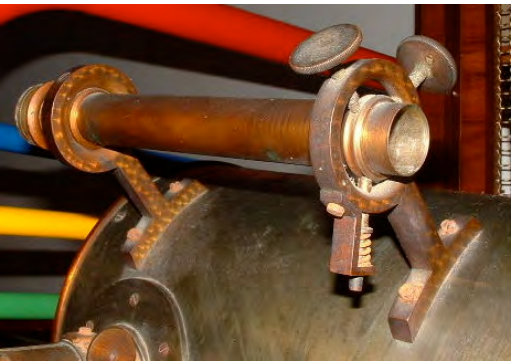
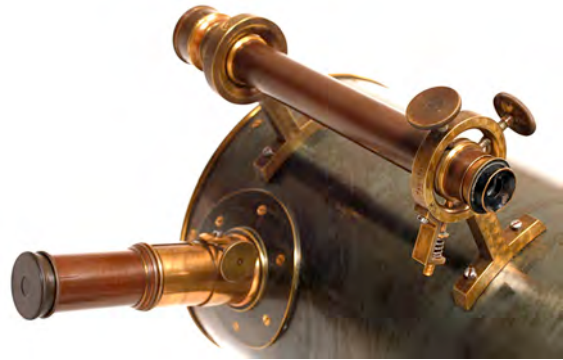
Replaced missing eyepiece in finder scope

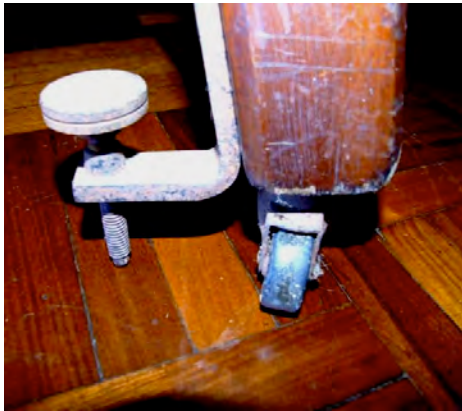
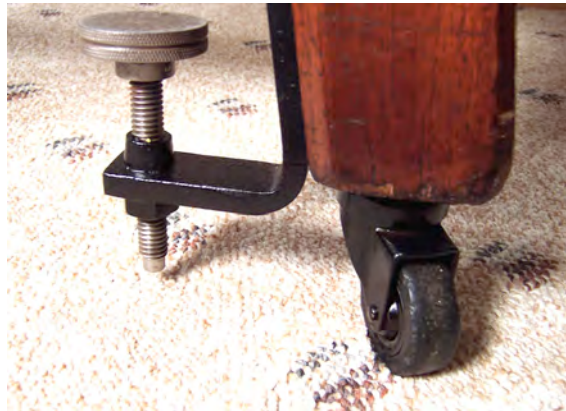
Straightened, cleaned and repainted with black satin enamel

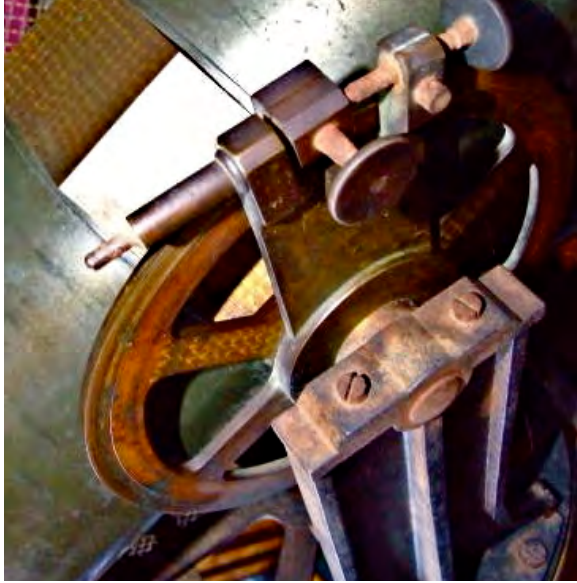
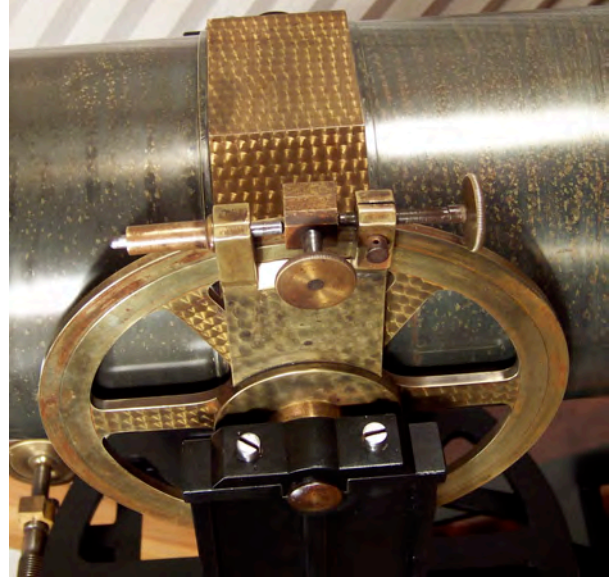
Declination adjuster and setting circle

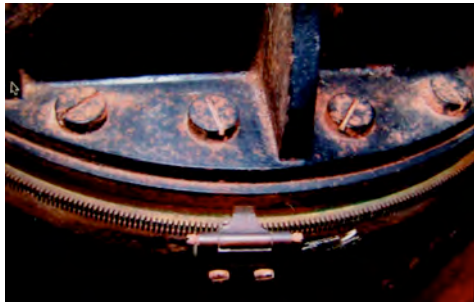
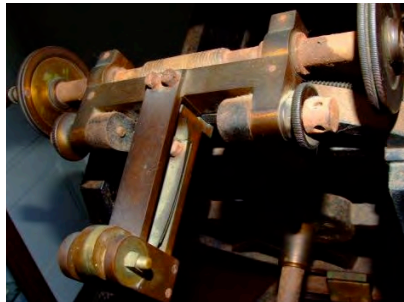
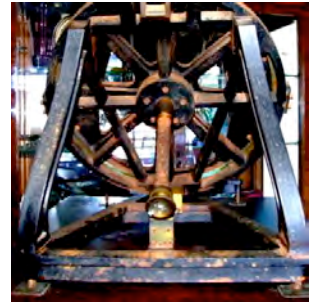
Rescued from heavy corrosion and non-functionality
